TEST REPORT

Reference No. : WTS17F0271006C

Sample Name : SIR

Test Requested : In accordance with Food and Drug Administration Regulations to test the following items
— Test for compliance with US FDA 21 CFR Part 177.2600

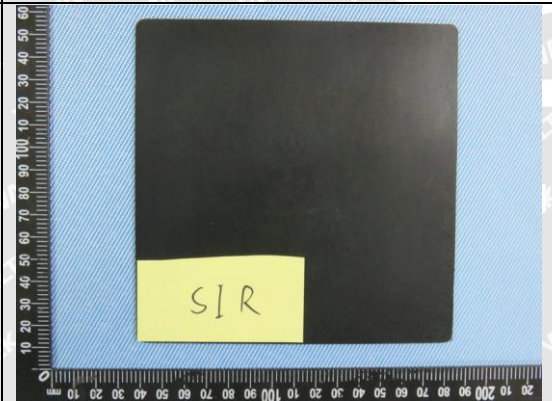
| No. | Photo of testing part | Parts Description | Client Claimed Material |
|---|---|---|---|
| 1 | | Black rubber | Rubber |
